Manhole Inspection Summary

Manhole # S33AA2011MH

Location Address: **5409 SPRINGLAKE WAY**

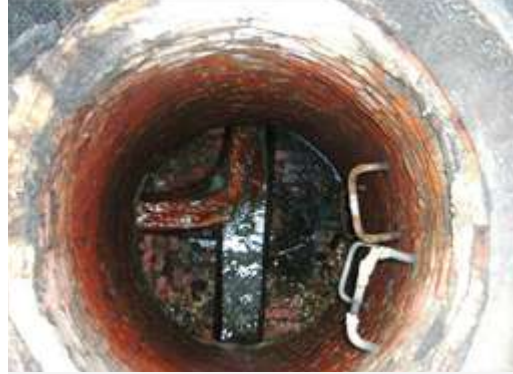
Top View

Corroded steps. Evidence of surcharge - Bench debris.

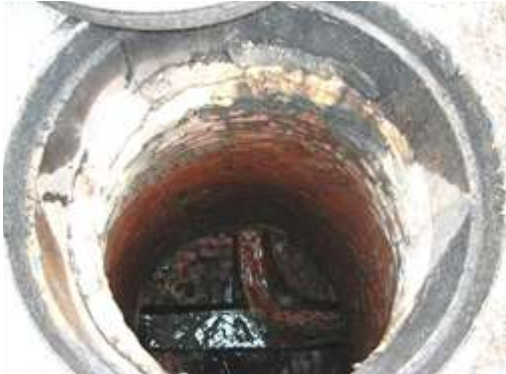
Defect

Frame leaks. Adjustment deterioration and infiltration. Barrel infiltration - other side.

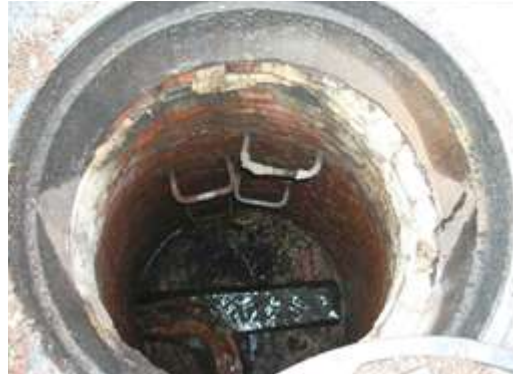
Defect

Frame leaks. Adjustment deterioration and infiltration.

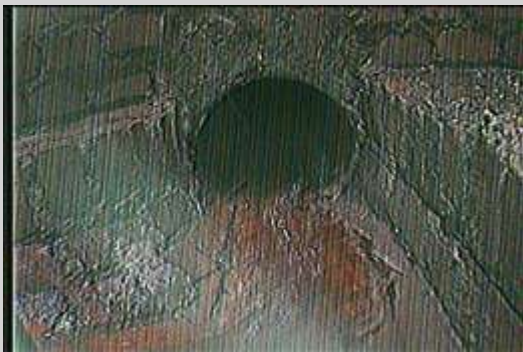
10 in. Circular Gravity Sewer Pipe Out @ 12 O'Clock

Barrel deterioration and infiltration. Channel deterioration.

Infiltration: **None** Pipe Seal Cond: **Cracked**

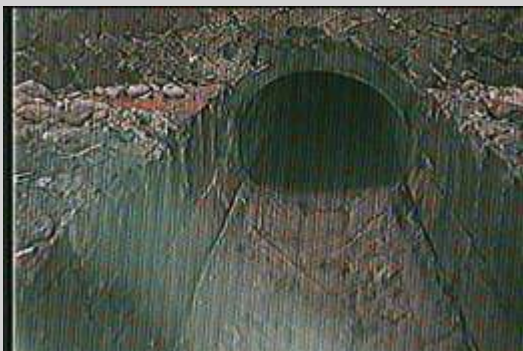
10 in. Circular Gravity Sewer Pipe In @ 6 O'Clock

Infiltration: **Evidence** Pipe Seal Cond: **Unknown**

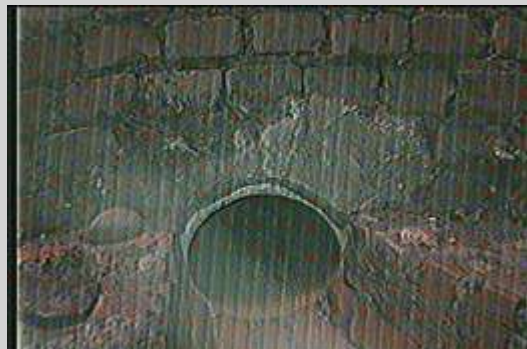
8 in. Circular Gravity Sewer

Barrel deterioration and infiltration. Channel deterioration.
